Manhole Inspection Summary

Manhole # S39G__020MH

Insp Date: **3/27/08 12:01 PM**

Location Address: **105 s. albemarle st**

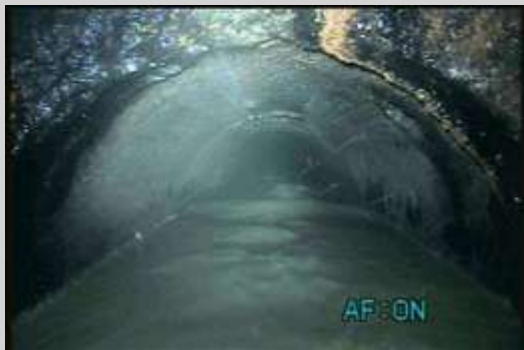
12 O'Clock Outflow

27 in. Circular Gravity Sewer
Pipe Out @ 12 O'Clock

Pipe Material: **Clay** ☐ Pipe Lined

Invert Depth: **19.66** (ft.) Flow Characteristics: **Fast**

Infiltration: **None** Pipe Seal Cond: **Unknown**

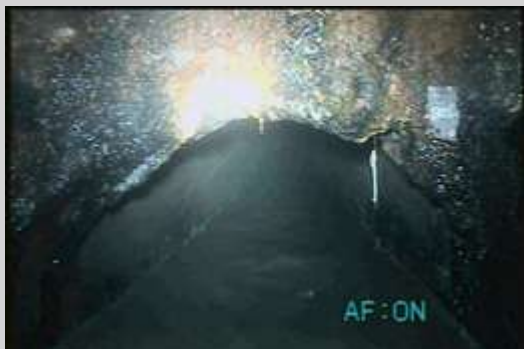
6 O'Clock Inflow

27 in. Circular Gravity Sewer
Pipe In @ 6 O'Clock

Pipe Material: **Clay** ☐ Pipe Lined

Infiltration: **None** Pipe Seal Cond: **Unknown**
